# **The Road Inventory of Deer Flat National Wildlife Refuge Nampa, ID**

Prepared By:  
Federal Highway Administration  
Central Federal Lands Highway Division  
April 2013

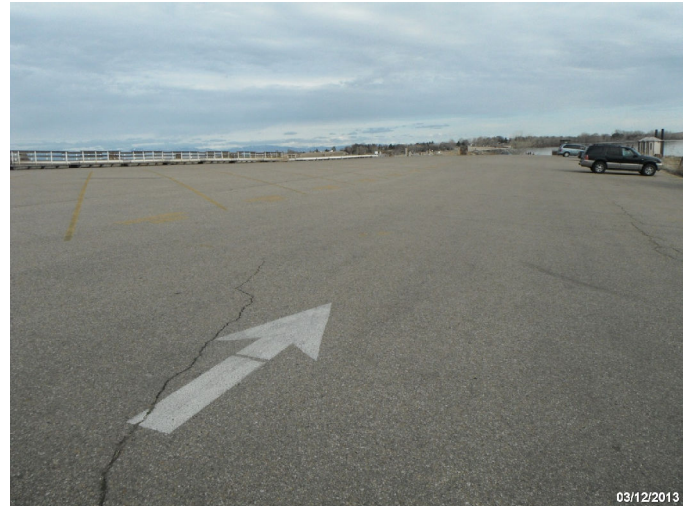
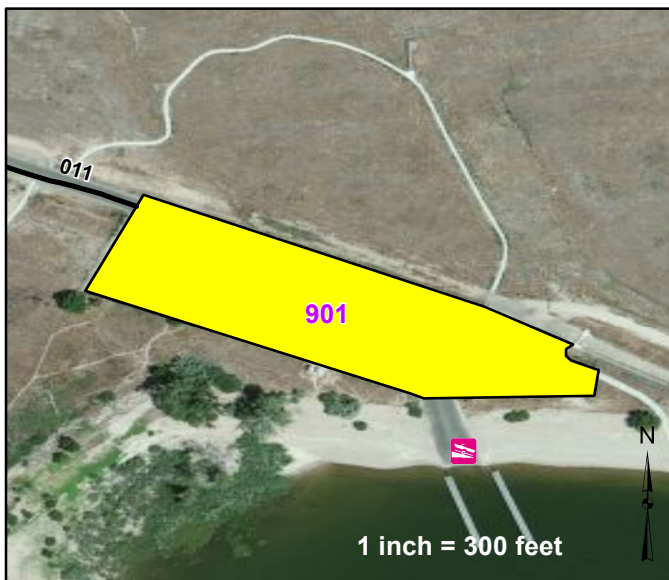
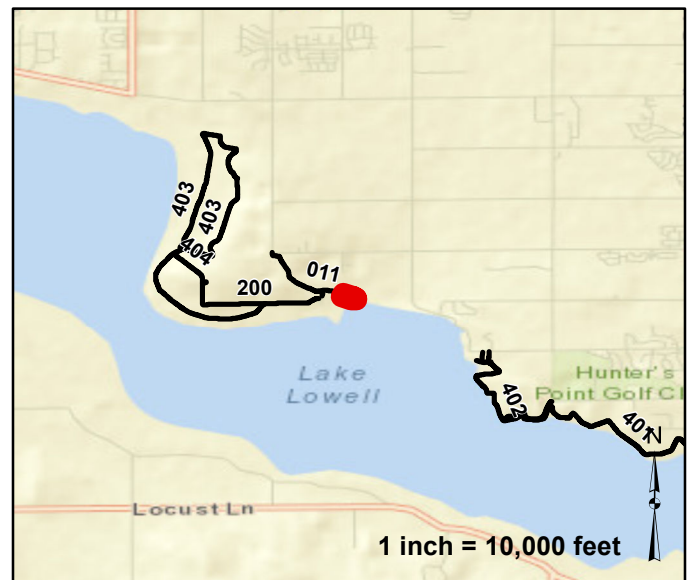
# Route Number: 901

Asset Number	Area (Sq Ft)	Spaces	Condition	Surface Type	Cost to Improve	Inspection Date	Current Replacement Value
10042374	84804	76	Fair	Asphalt	\$74,000	03-12-2013	\$784,600

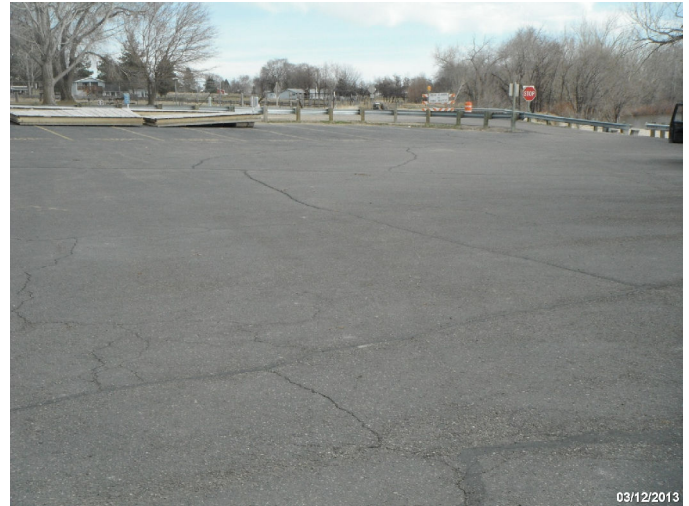
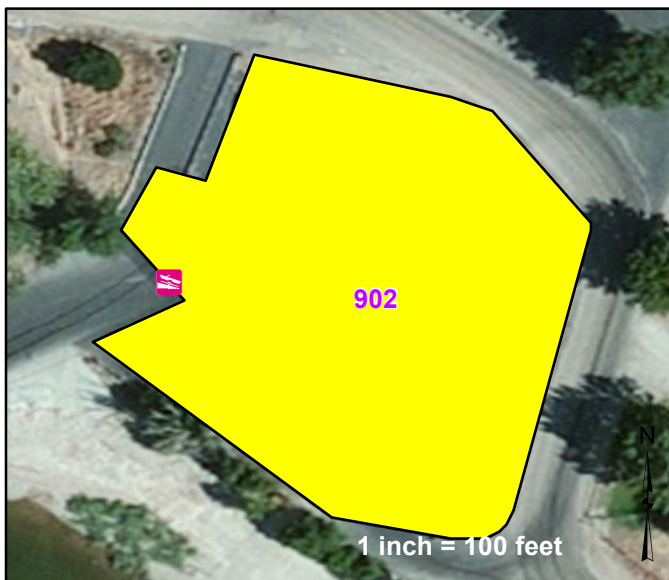
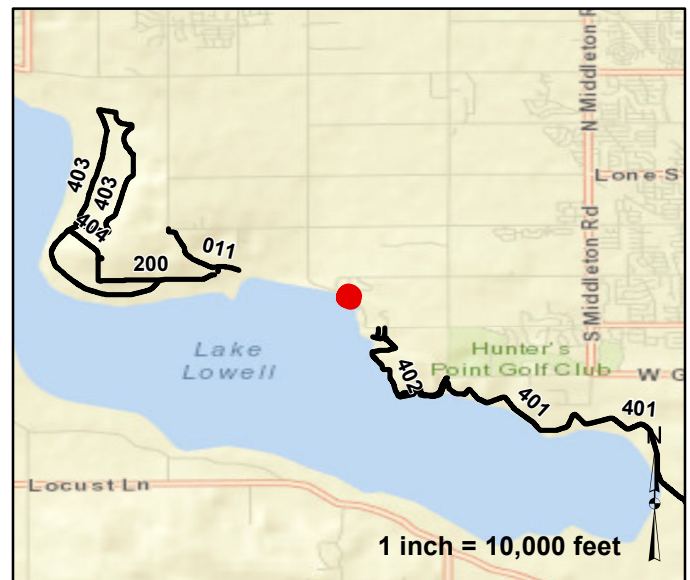
**Route Number: 902**  
**Upper Dam East Parking**  
**From Lake Avenue**

Asset Number	Area (Sq Ft)	Spaces	Condition	Surface Type	Cost to Improve	Inspection Date	Current Replacement Value
10042375	31077	35	Fair	Asphalt	\$27,100	03-12-2013	\$287,500

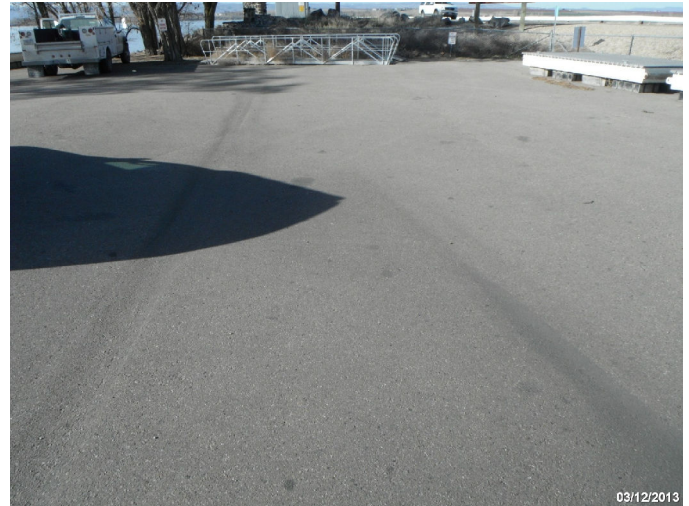
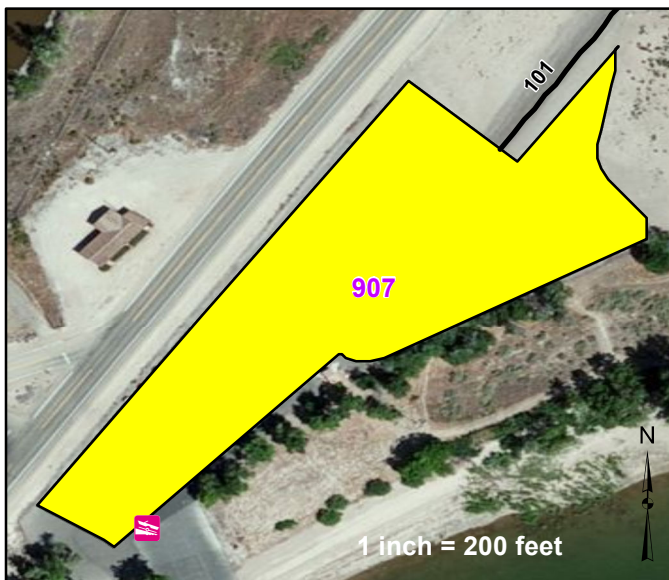
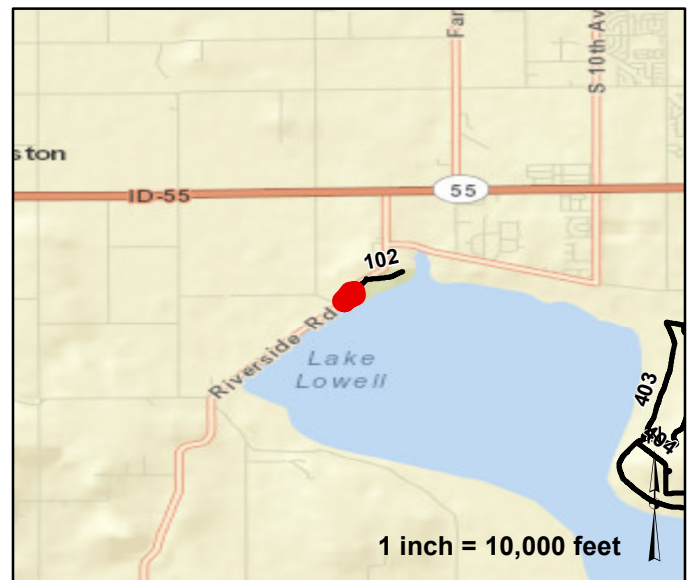
# Route Number: 907

Asset Number	Area (Sq Ft)	Spaces	Condition	Surface Type	Cost to Improve	Inspection Date	Current Replacement Value
10005337	75936	52	Fair	Asphalt	\$66,300	03-12-2013	\$702,600

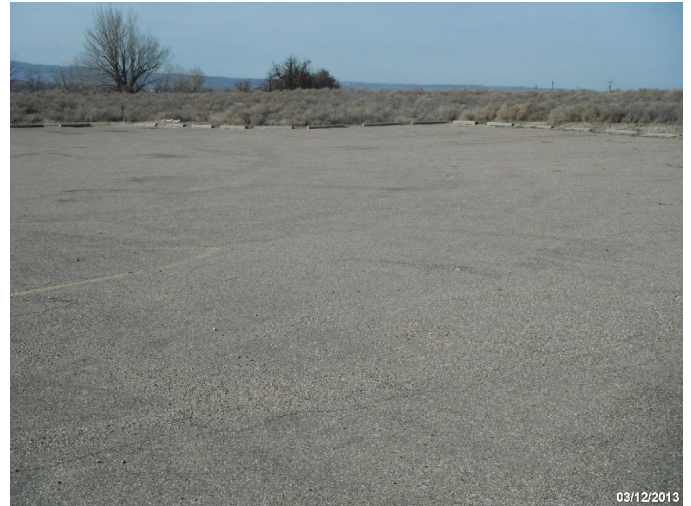
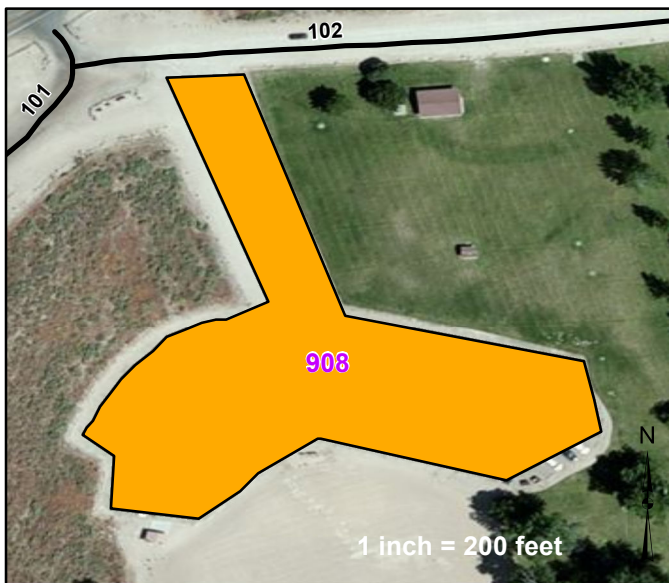
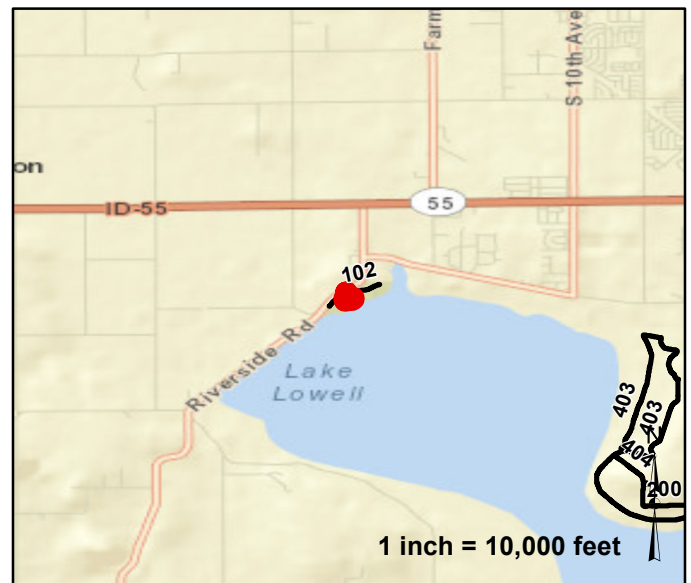
# Route Number: 908

Asset Number	Area (Sq Ft)	Spaces	Condition	Surface Type	Cost to Improve	Inspection Date	Current Replacement Value
10005338	67454	134	Poor	Asphalt	\$329,600	03-12-2013	\$624,100
